REPAIR INSTRUCTION NO. RI-1078-93/1

G 115E / EG all as affected

Repair of hinge bracket attachment points – FLAPS

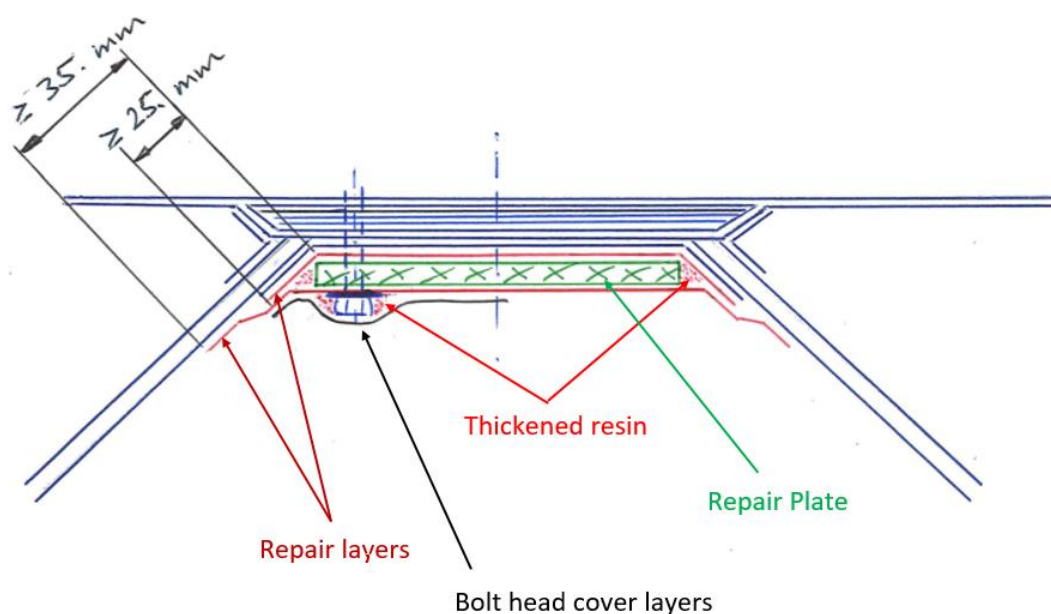
Figure 4: Repair schematic for location 7/12 sectional view

Note: If the access hole at location 7/12 is cut into the lower flap surface, it might be necessary to grind the upper shell locally for the installation of the bolts, refer to Figure 4.

CAUTION: At location 7/12 a 6mm thick repair plate (instead of 4mm) is installed with longer bolts of a higher strength category.

- 7.1.9 If location 7/12 (refer to Figure 1) is repaired, pre-install the respective repair plate, washers and bolts to check if material from the inner shell has to be removed for the installation of the bolts. If required the inner shell can be grinded locally for installation of the bolts (refer to Figure 4). Remove the bolts, washers and repair plate after verification.
- 7.1.10 Remove the grinding dust with a vacuum cleaner.

- 7.1.16 Bond the repair plate with the non-chamfered side through the tapered bolts on top of the repair. If required, smoothen out the excessive resin at the edges of the repair plate to gain a transition to the spar.
- 7.1.17 If the inner shell has been grinded locally at location 7/12 i.a.w. step 7.1.9, fill the grinded area with thickened resin. If required fill up the spar/shell transition with thickened resin for a smooth overlap repair (refer to [Figure 4](#) and [Figure 5](#)).
- 7.1.18 If Location 7/12 is repaired, cover the repair plate with two additional layers of glass fabric GS510031 $\pm 45^\circ$, refer to [Figure 4](#) and [Figure 5](#).
- 7.1.19 Remove the tapered bolts.
- 7.1.20 Install four washers (item 5 of List 9) and four bolts (refer to Table 1 for the P/N of the bolts), refer to [Figure 7](#). If required, clean the thread of the bolts from resin.
